NL INDUSTRIES/TARACORP SUPERFUND SITE GROUP

**Re: NL Industries/Taracorp Superfund Site; Granite City, Illinois
Second 2017 Semi-Annual Operation and Maintenance Inspection (December 2017)**

**NL Industries/Taracorp Superfund Site
Inspection Log - Operation and Maintenance**

Inspection Date: 12/4/2017
Weather: Cloudy, windy, 55 F - 60 F

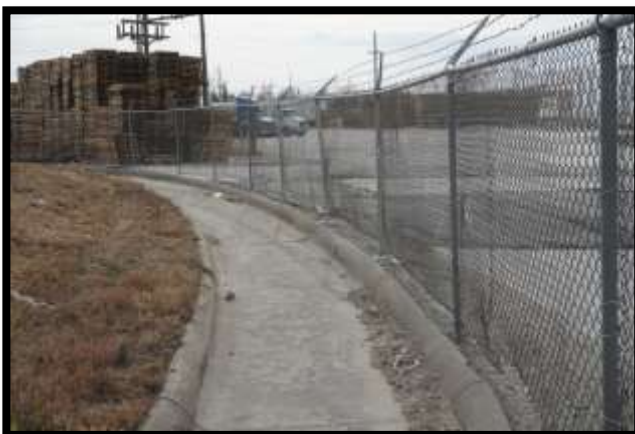
Photograph 28: Fence and concrete drainage swale (southwestern side of Taracorp pile cap).

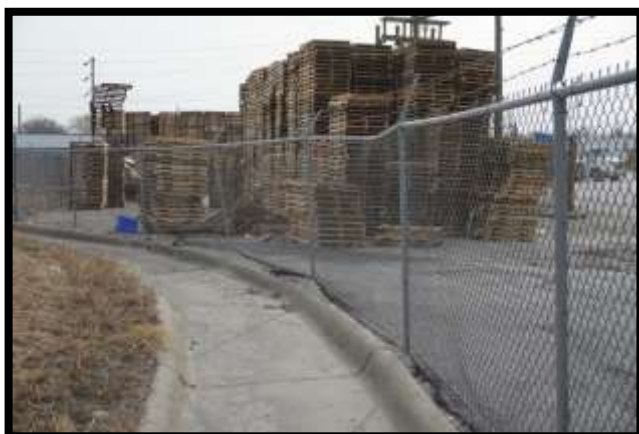
Photograph 29: Fence and concrete drainage swale (southwestern side of Taracorp pile cap).

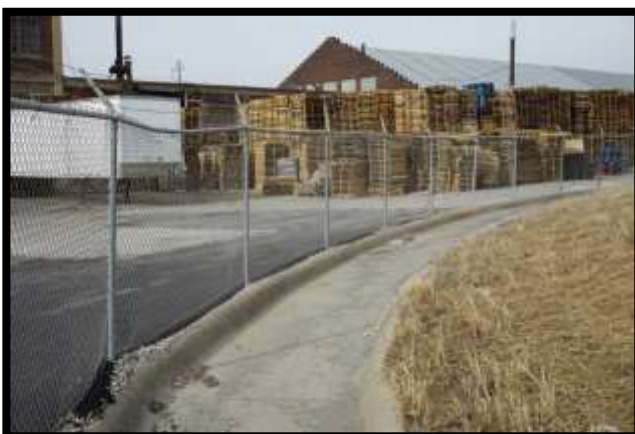
Photograph 30: Fence and concrete drainage swale (southwestern side of Taracorp pile cap).

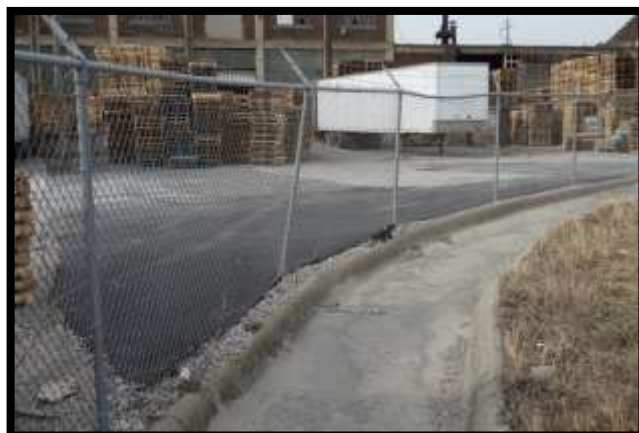
Photograph 31: Fence and concrete drainage swale (southwestern side of Taracorp pile cap).

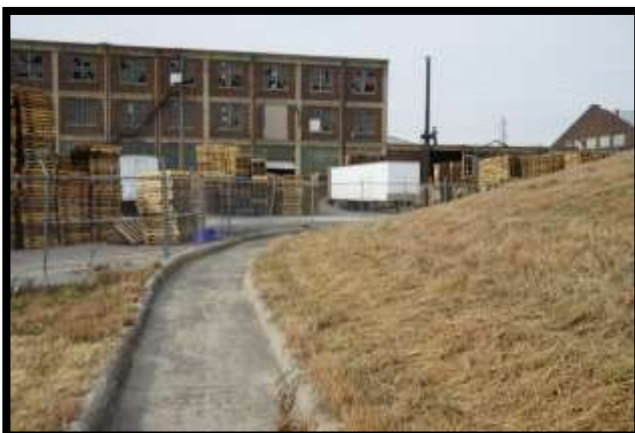
Photograph 32: Fence and concrete drainage swale (southwestern side of Taracorp pile cap).

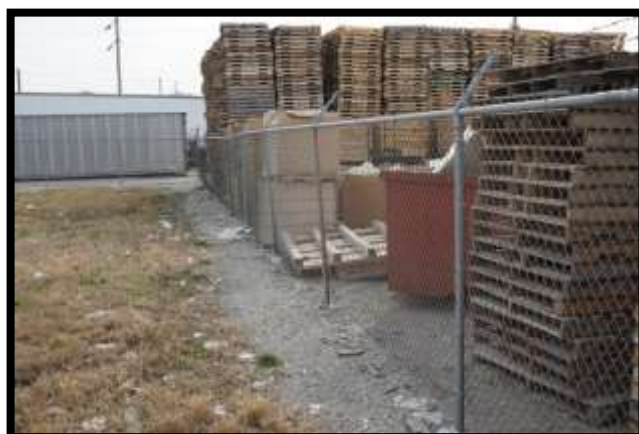
Photograph 33: Fence (material staging on State Street Warehouse property).

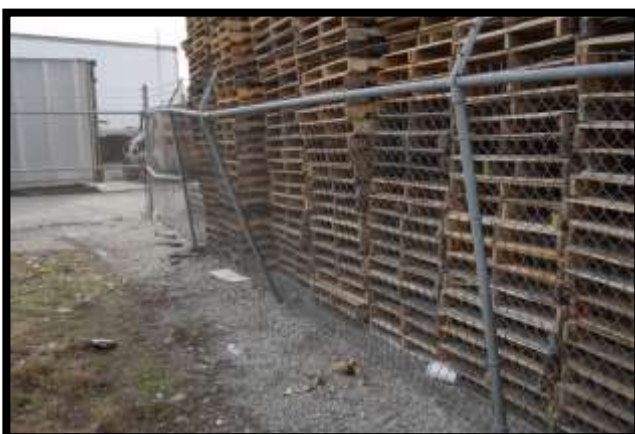
Photograph 34: Fence (material staging on State Street Warehouse property).

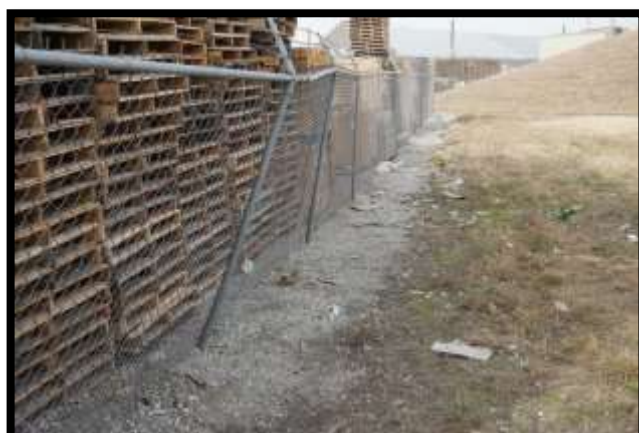
Photograph 35: Fence (material staging on State Street Warehouse property).

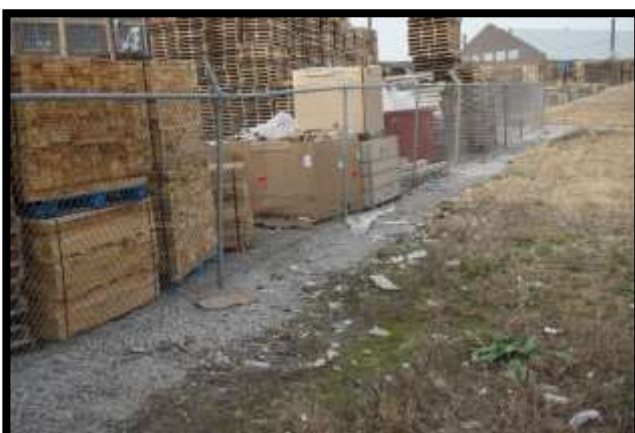
Photograph 36: Fence (material staging on State Street Warehouse property).

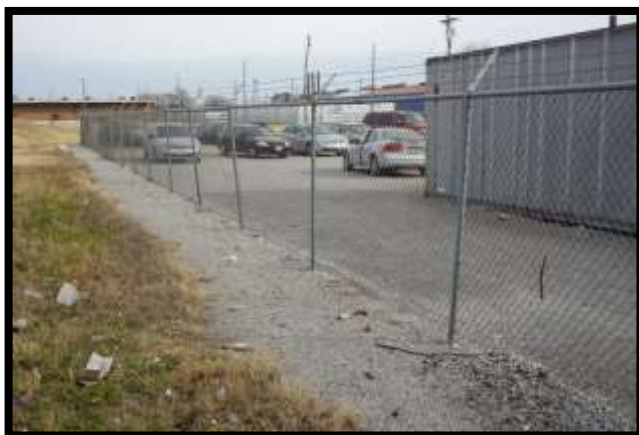
Photograph 37: Fence (material staging on State Street Warehouse property).

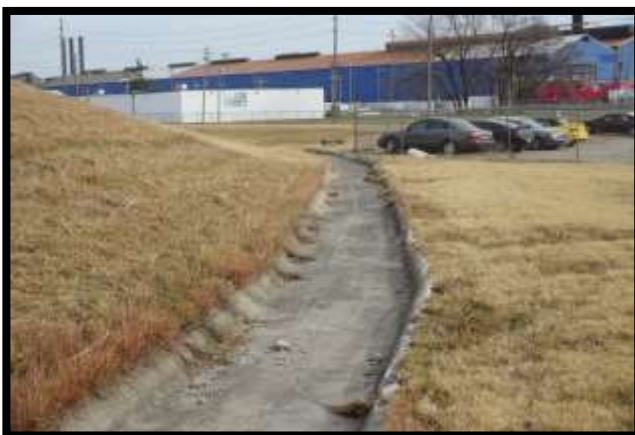
Photograph 38: Concrete drainage swale along southern slope of Taracorp pile.

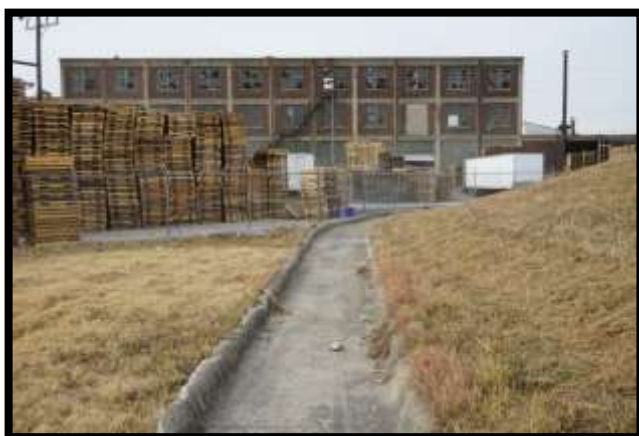
Photograph 39: Vegetation and concrete drainage swale along southern slope of Taracorp cap pile (view west).

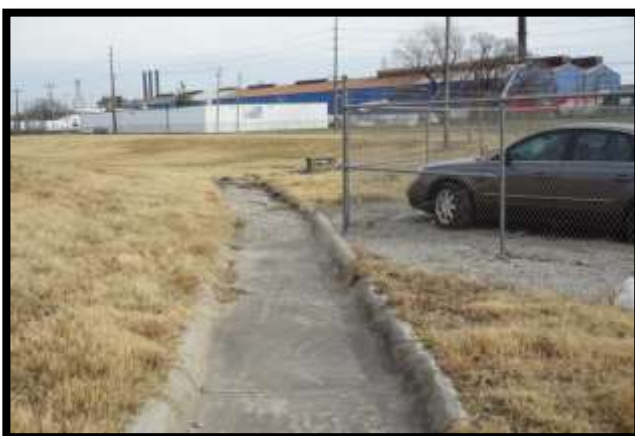
Photograph 40: Concrete drainage swale along southern slope of Taracorp pile.

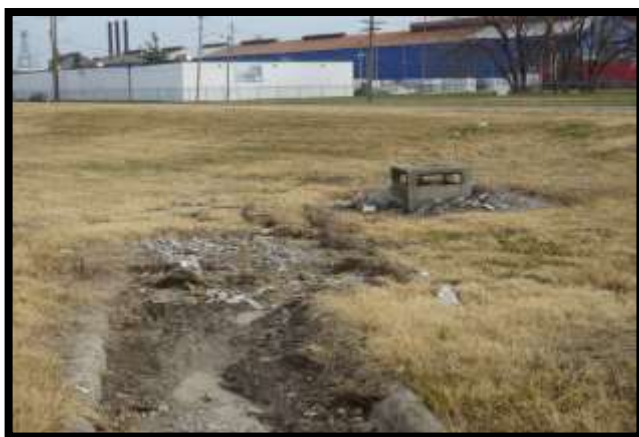
Photograph 41: Concrete drainage swale along southern slope of Taracorp pile.

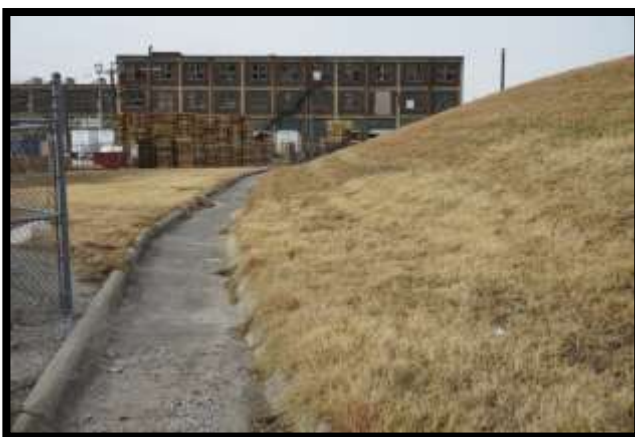
Photograph 42: Concrete drainage swale along southern slope of Taracorp pile.

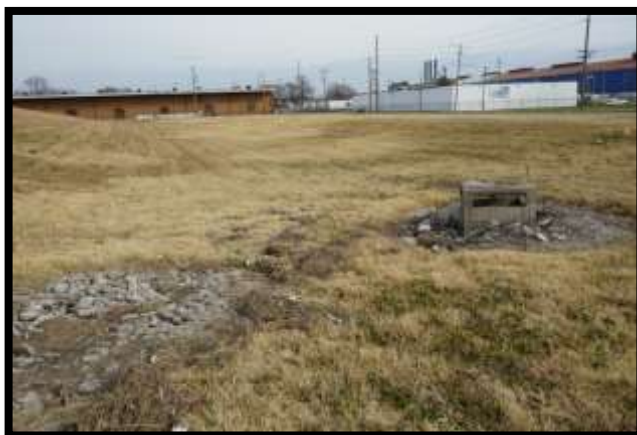
Photograph 43: Vegetation along southeast side of Taracorp pile cap (view northeast).

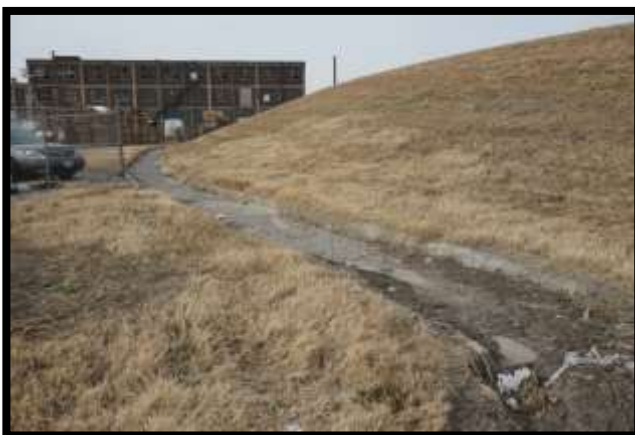
Photograph 44: Southern side of Taracorp pile (view west).

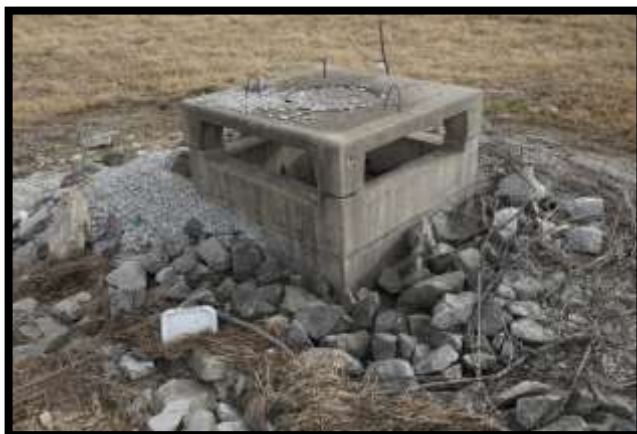
Photograph 45: Stormwater outlet.

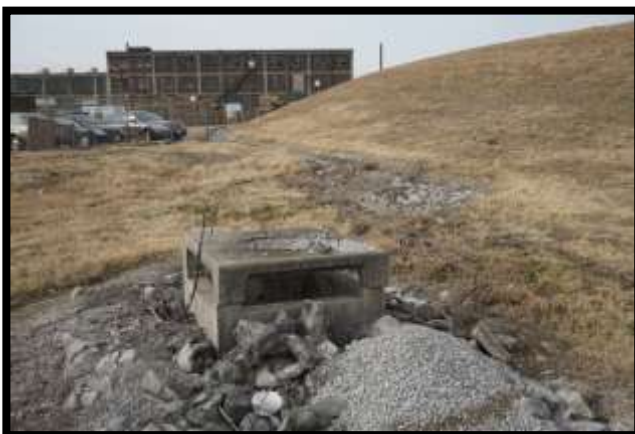
Photograph 46: Stormwater outlet.

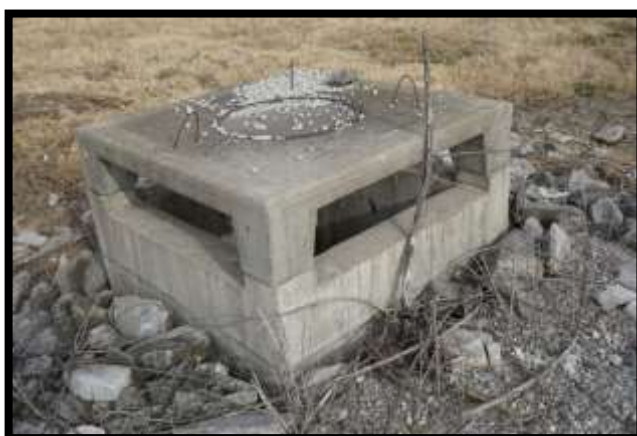
Photograph 47: Stormwater outlet.

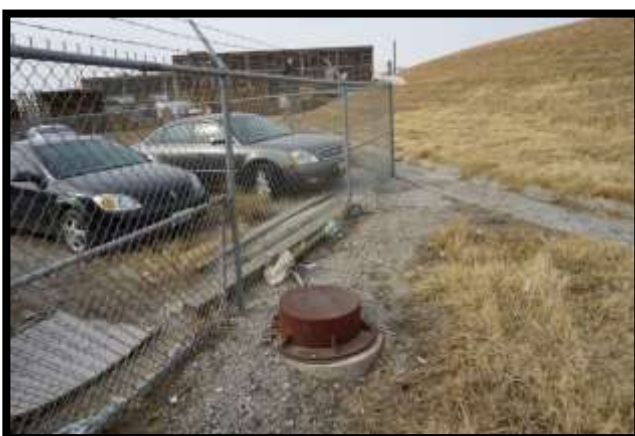
Photograph 48: Stormwater manhole near fence.

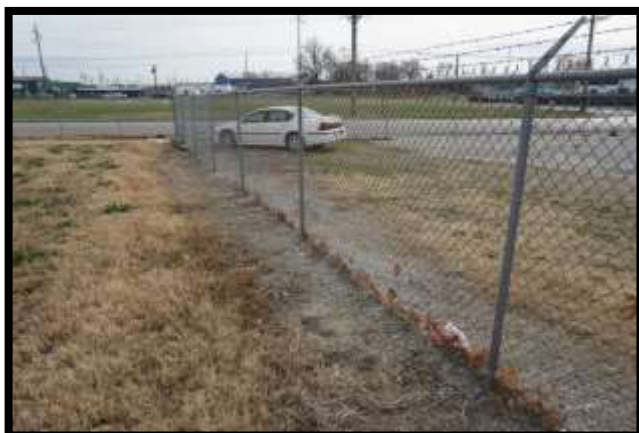
Photograph 49: Vegetation and fence near former Rich Oil facility (view toward State Street).

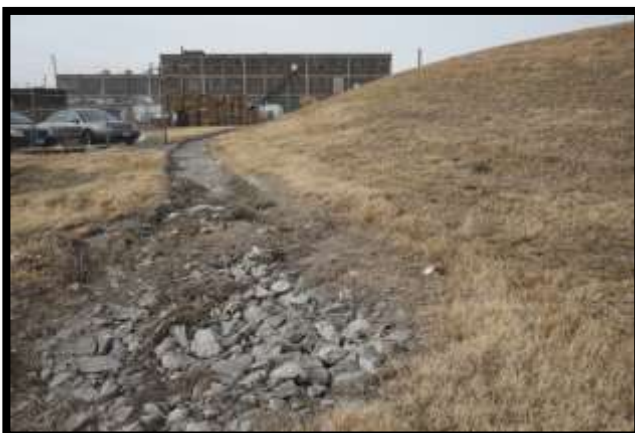
Photograph 50: Vegetation, southern side of Taracorp pile cap.

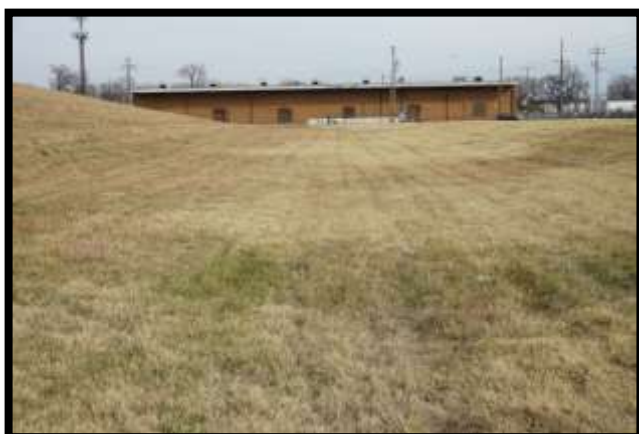
Photograph 51: Vegetation, stormwater retention basin, eastern side of Taracorp pile cap.

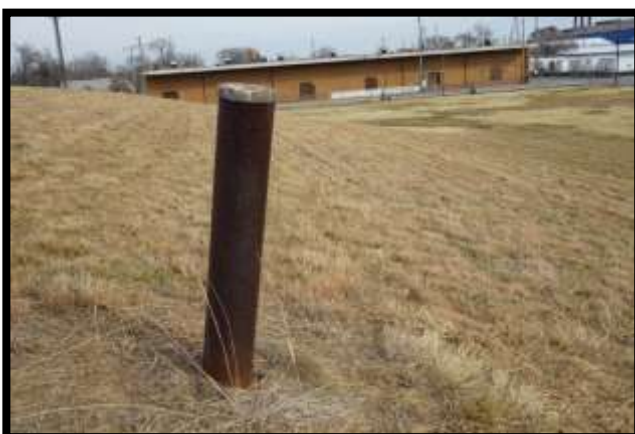
Photograph 52: Leachate riser pipe.

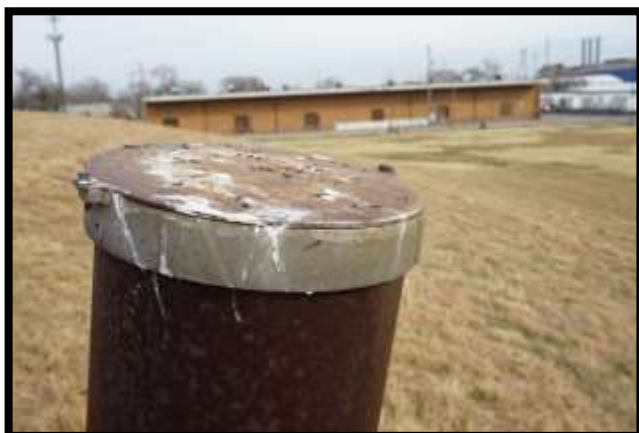
Photograph 53: Locked lid on leachate riser pipe (locked lid installed fall 2007).

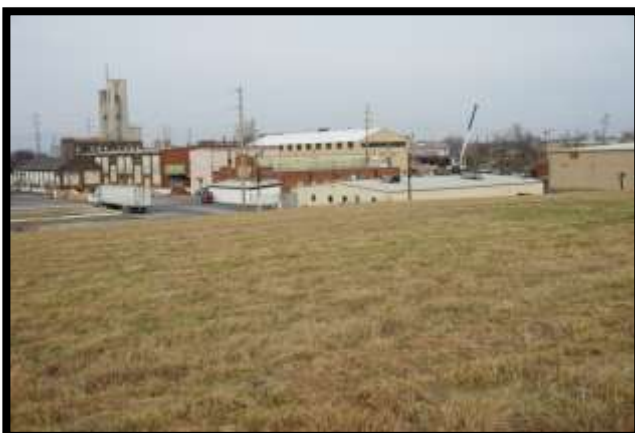
Photograph 54: Vegetation, top of Taracorp pile (view northwest).

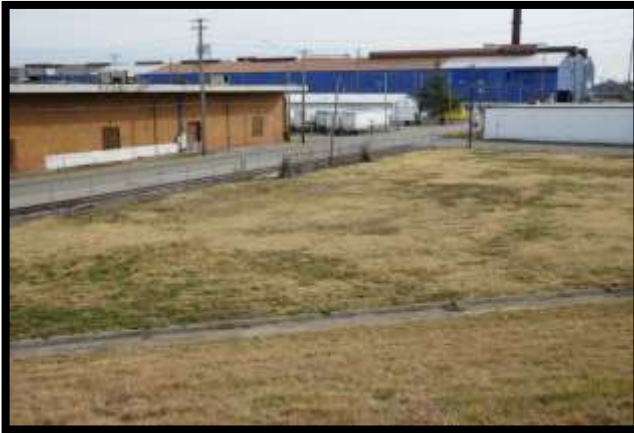
Photograph 55: Vegetation, former BV&G Truck Service area.

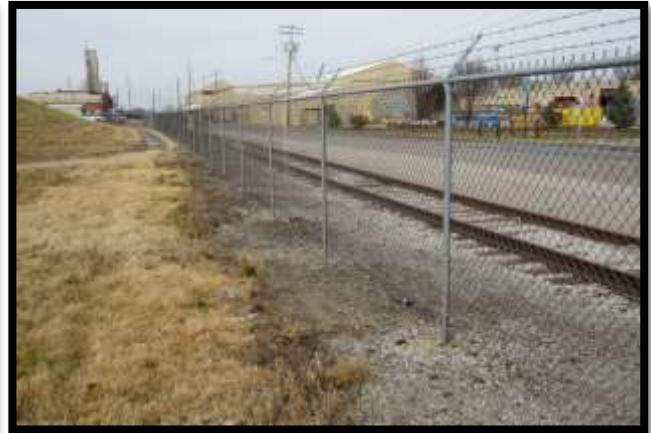
Photograph 56: Vegetation near fence along railroad tracks.

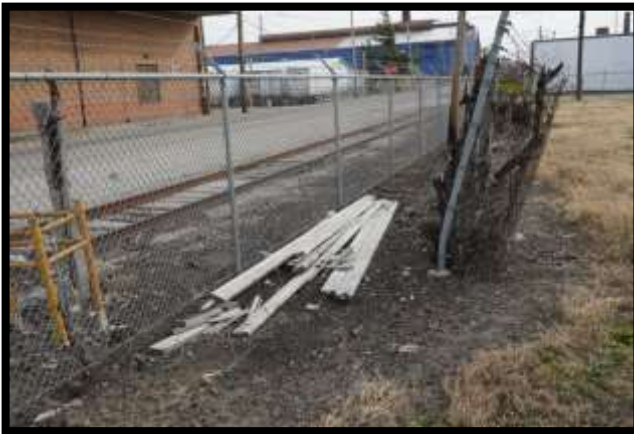
Photograph 57: Older and newer fence near former BV&G Truck Service buildings and along railroad tracks (view northeast).

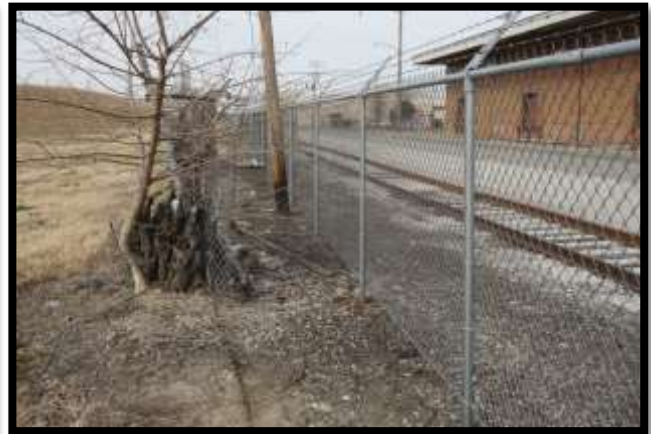
Photograph 58: Older and newer fence near former BV&G Truck Service buildings along railroad tracks (view northwest).

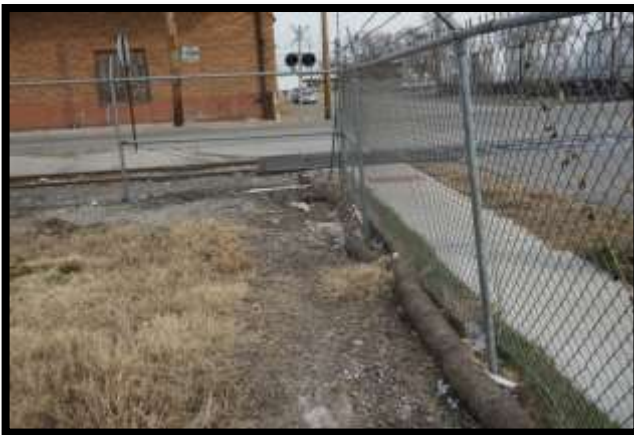
Photograph 59: Inside fence, corner of State Street and 16th Street.

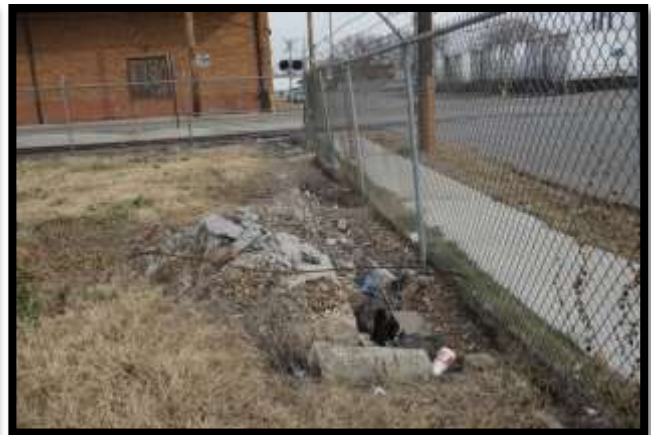
Photograph 60: Inside fence, corner of State Street and 16th Street.

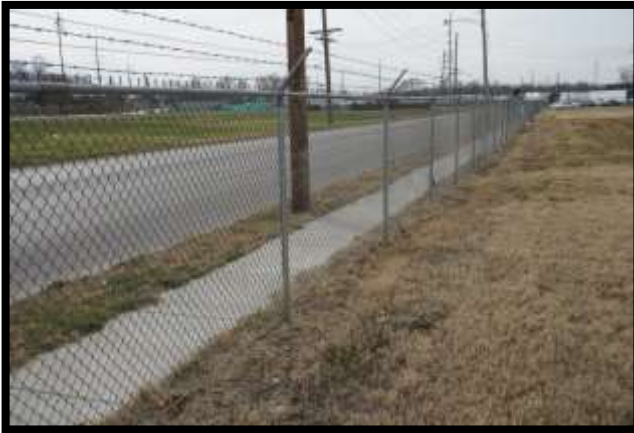
Photograph 61: Inside fence, view south along State Street.

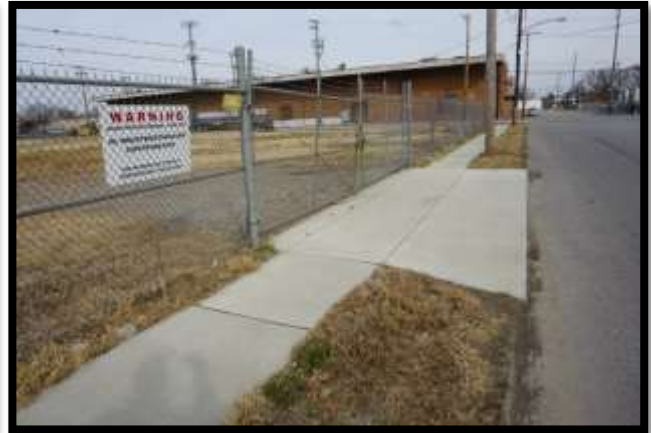
Photograph 62: Concrete entranceway gate near 16th and State Streets.

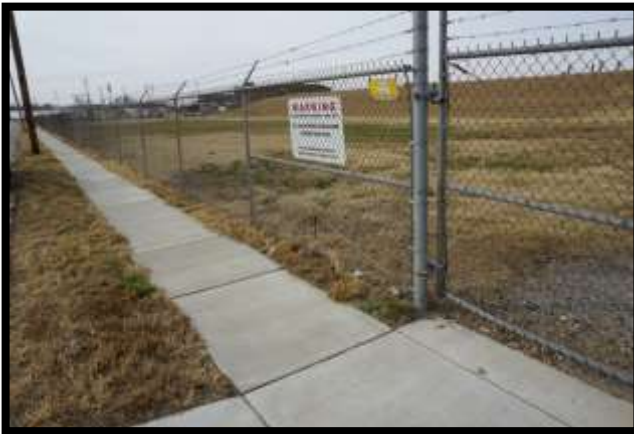
Photograph 63: Fence, grass, and sidewalk along State Street.

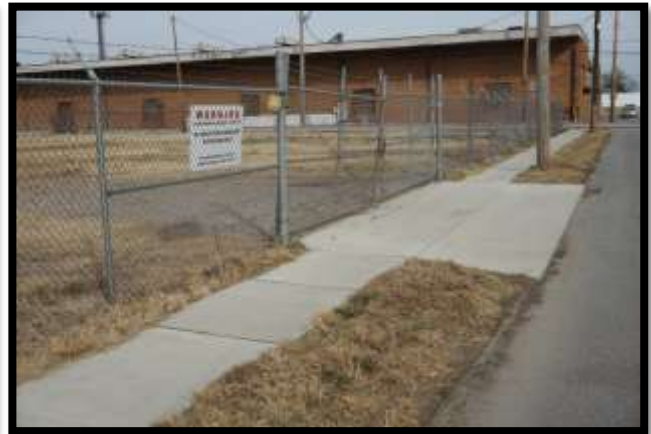
Photograph 64: Fence, grass, and sidewalk along State Street.

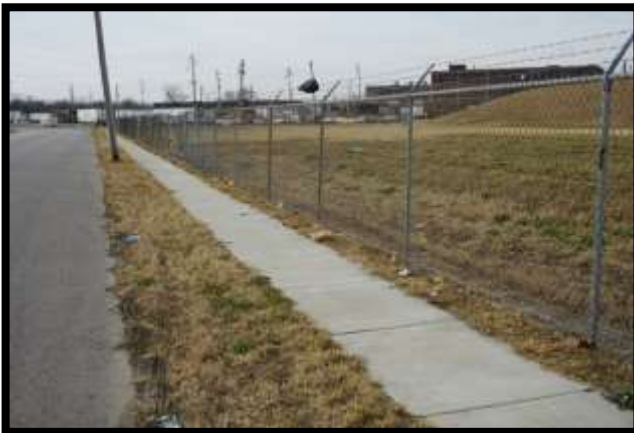
Photograph 65: Fence, grass, and sidewalk along State Street.

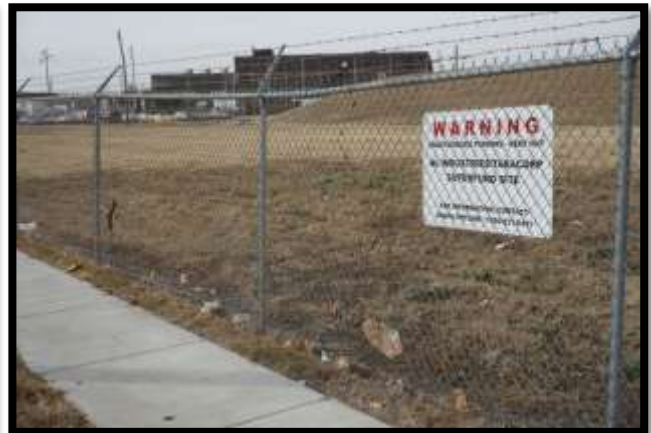
Photograph 66: Warning sign along State Street.

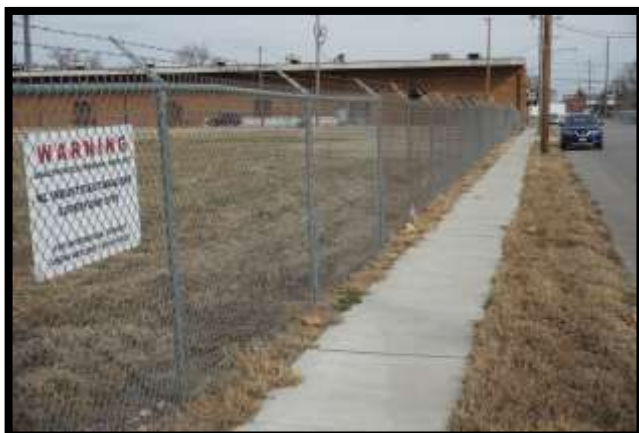
Photograph 67: Warning sign along State Street.

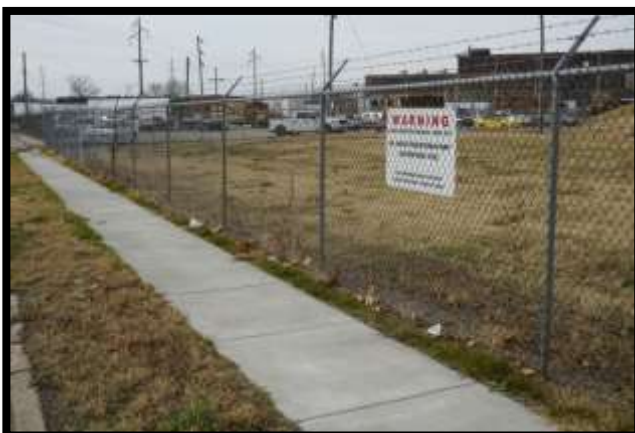
Photograph 68: Warning sign along State Street.

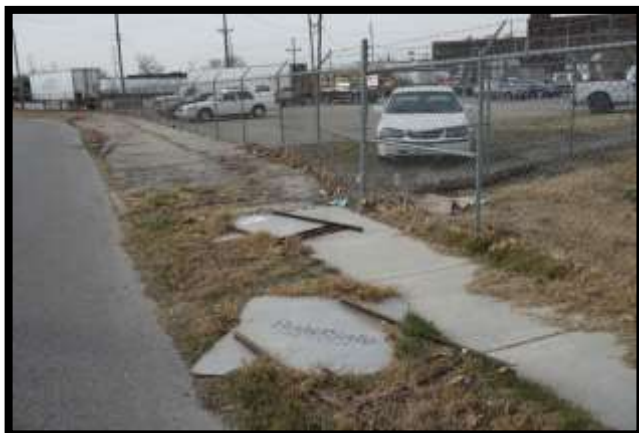
Photograph 69: Southern end of concrete sidewalk on **non-responsive** property (adjacent to former Rich Oil property).

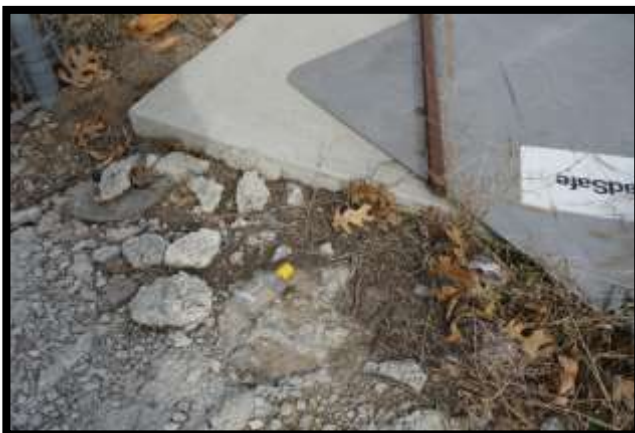
Photograph 70: Southern end of concrete sidewalk on **non-responsive** property (adjacent to former Rich Oil property).

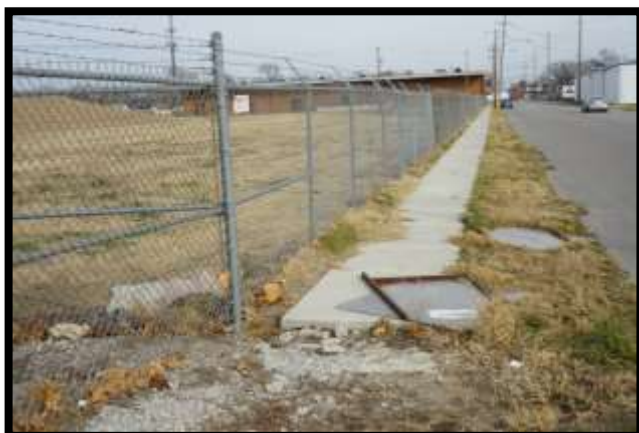
Photograph 71: Southern end of concrete sidewalk on **non-responsive** property (adjacent to former Rich Oil property).

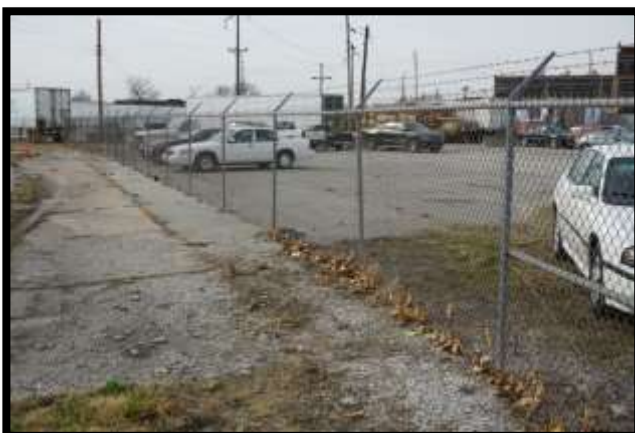
Photograph 72: Former Rich Oil property.

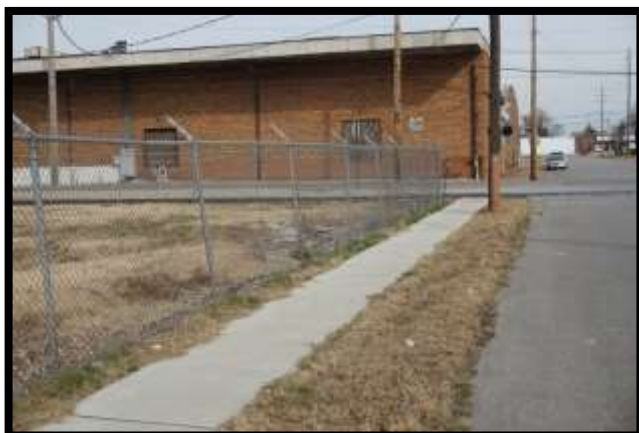
Photograph 73: Fence, grass, and sidewalk along State Street.

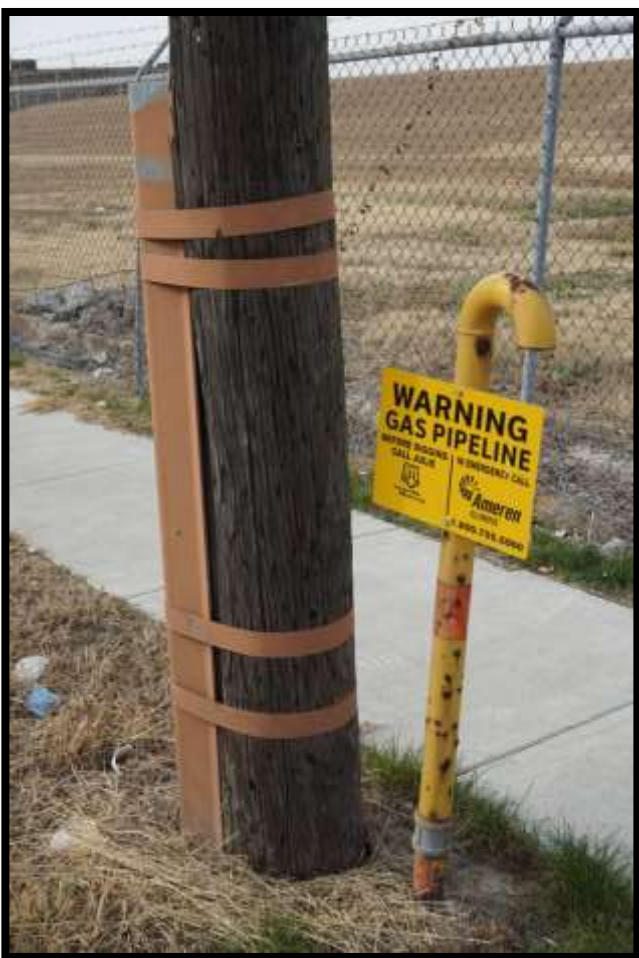
Photograph 75: Utility pole near intersection of [redacted] non-responsive

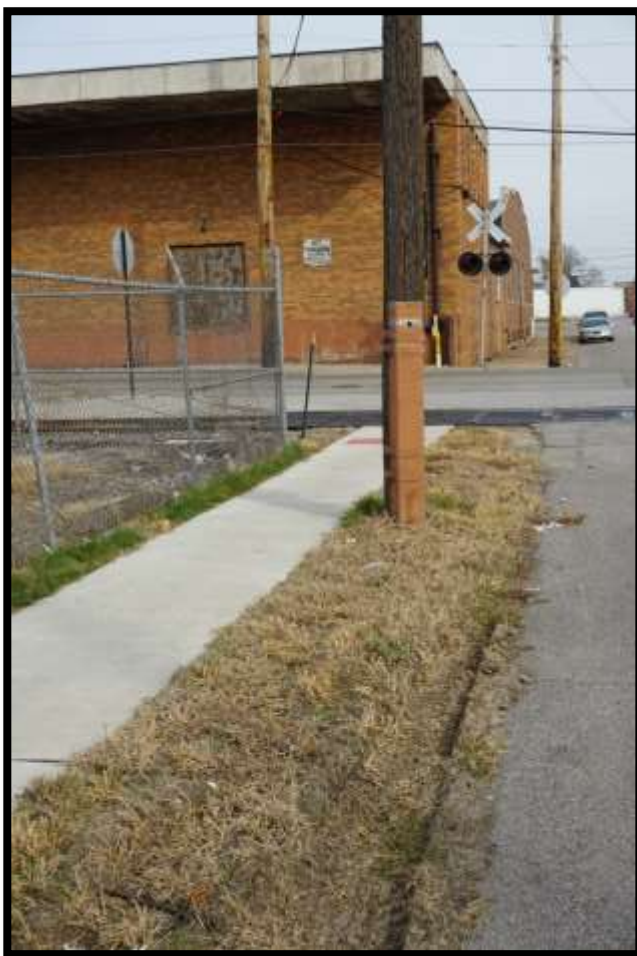
Photograph 74: Utility pole near intersection of [redacted] non-responsive

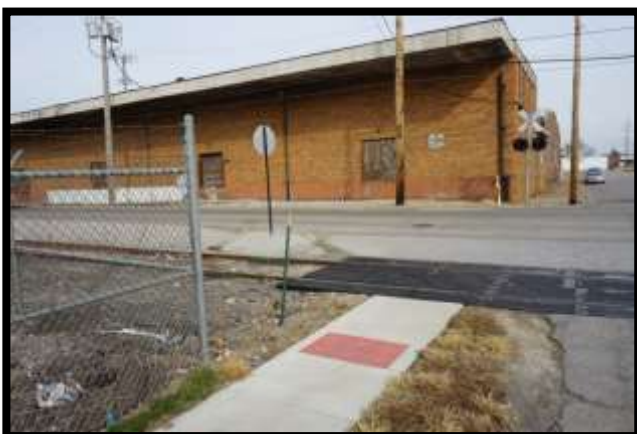
Photograph 76: End of sidewalk along railroad tracks.

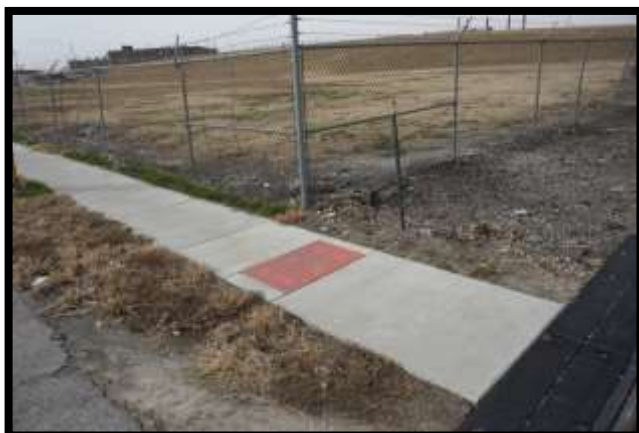
Photograph 77: End of sidewalk along railroad tracks.

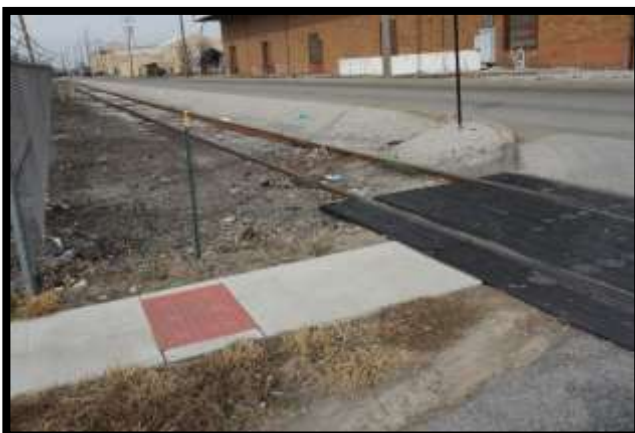
Photograph 78: End of sidewalk along railroad tracks.

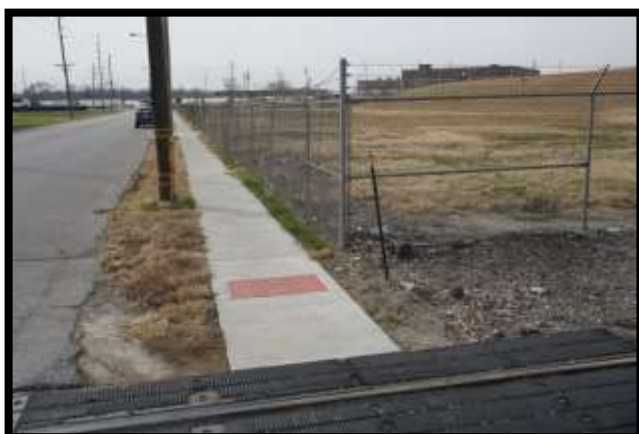
Photograph 79: End of sidewalk along railroad tracks.

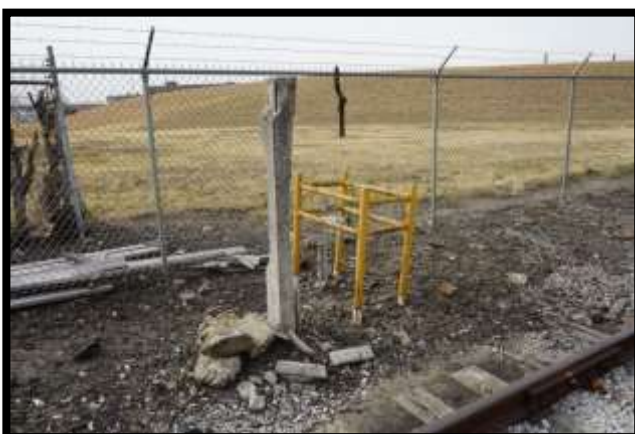
Photograph 80: Gas utilities along railroad tracks.

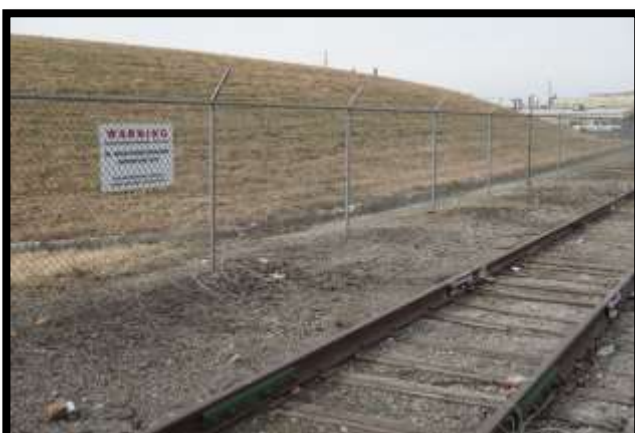
Photograph 82: Warning sign on fence along railroad tracks near 1st Street.

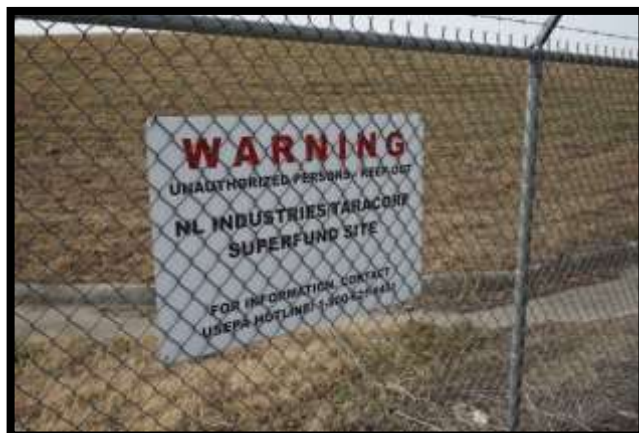
Photograph 83: Warning sign on fence along railroad tracks near [REDACTED].

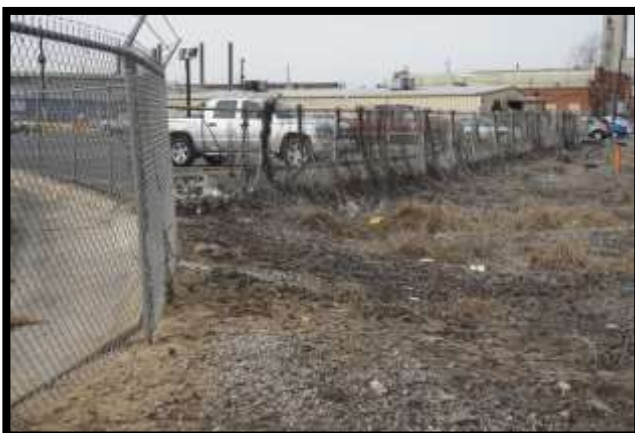
Photograph 84: Fence and vegetation along railroad tracks and [REDACTED].

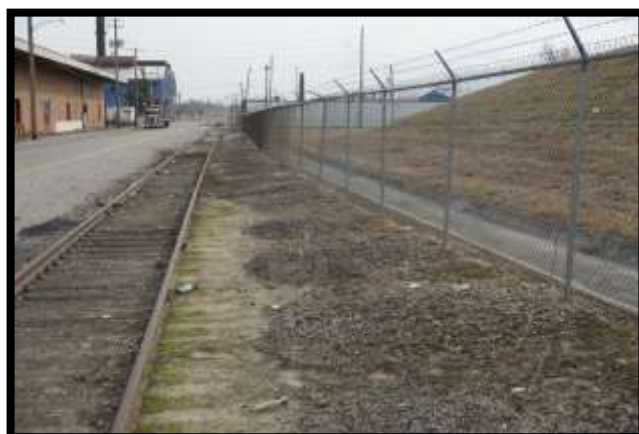
Photograph 85: Fence and vegetation along railroad tracks and [REDACTED].

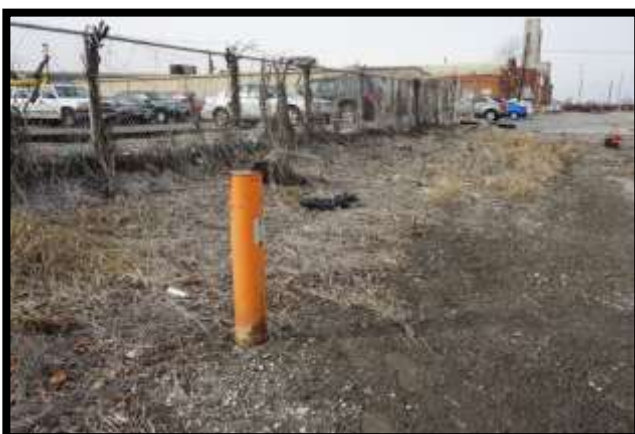
Photograph 86: Monitoring well, fence, and vegetation along railroad tracks and [REDACTED].

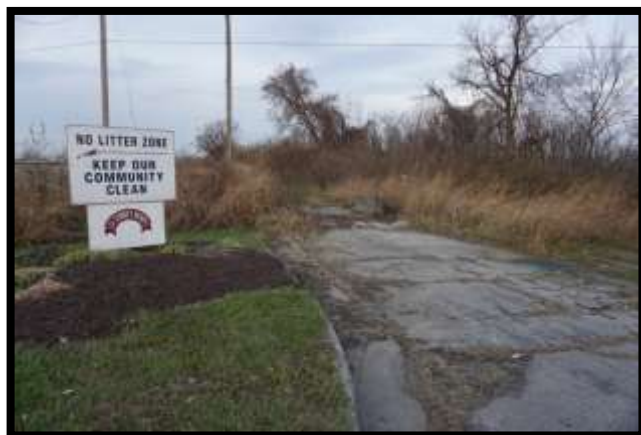
Photograph 1: Schaeffer Road property.

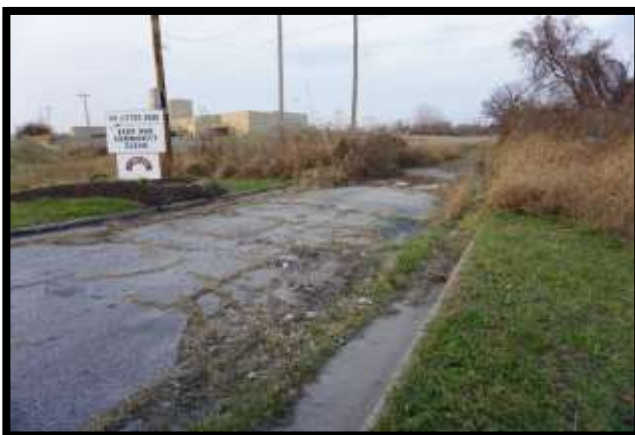
Photograph 2: Schaeffer Road property.

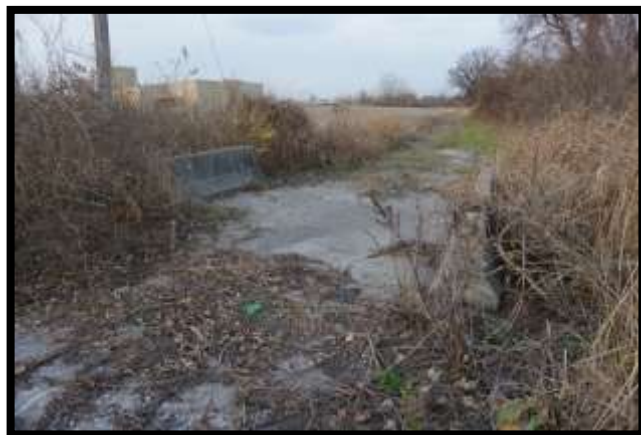
Photograph 3: Schaeffer Road property.

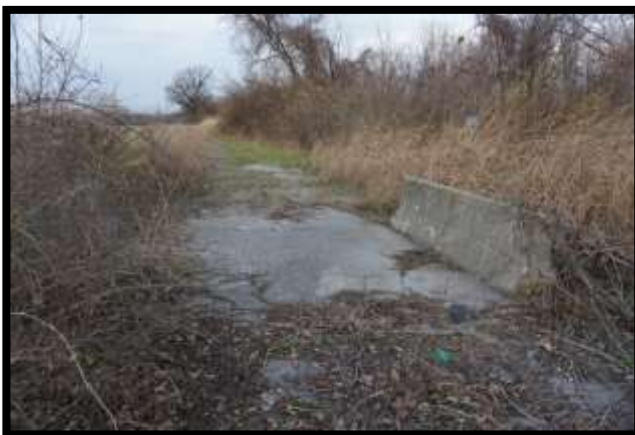
Photograph 4: Schaeffer Road property.

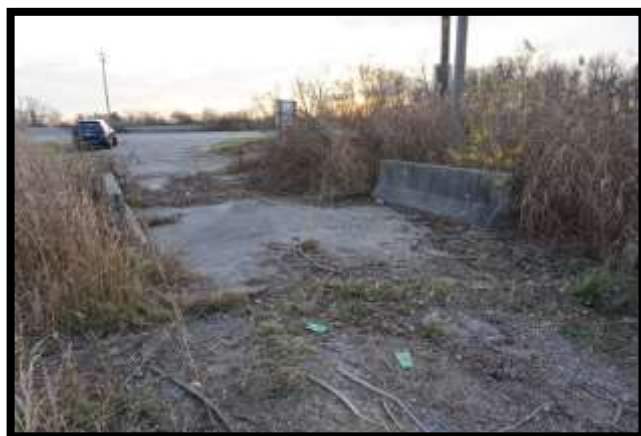
Photograph 5: Schaeffer Road property.

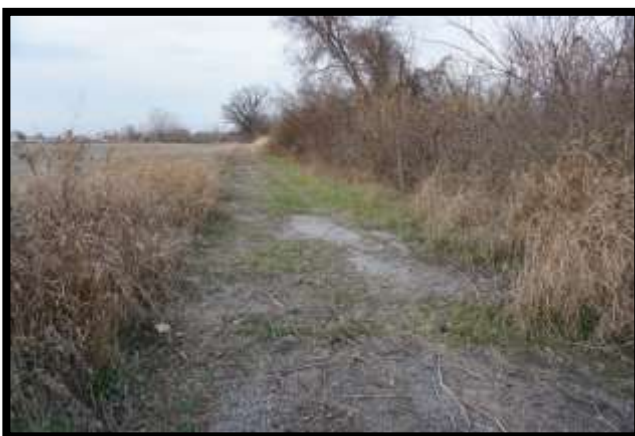
Photograph 6: Schaeffer Road property.

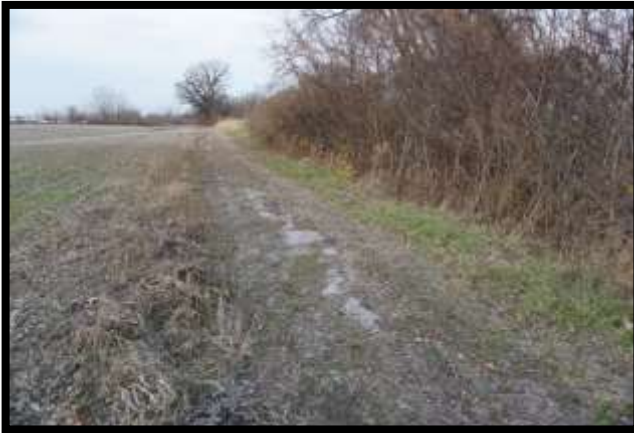
Photograph 7: Schaeffer Road property.

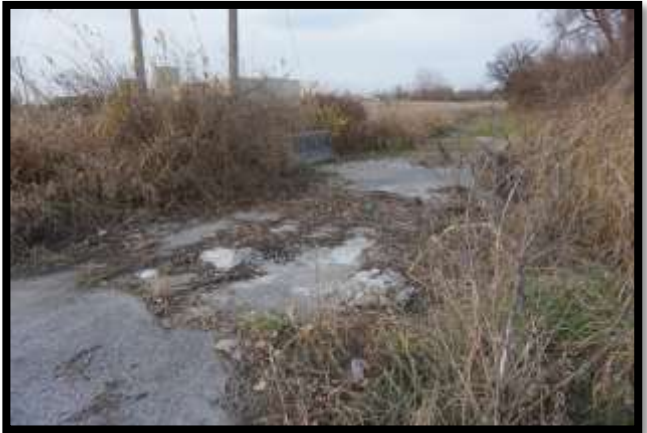
Photograph 8: Schaeffer Road property.

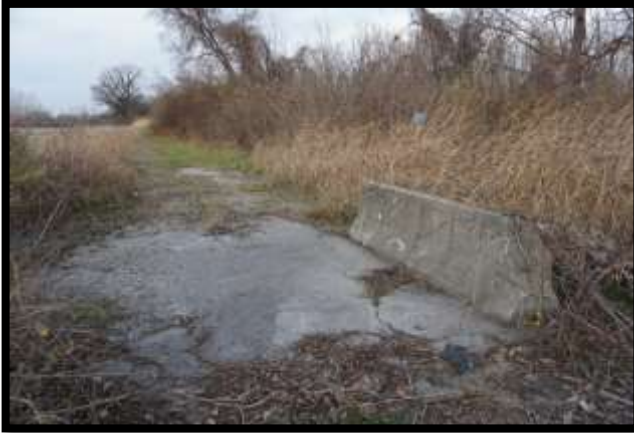
Photograph 9: Schaeffer Road property.

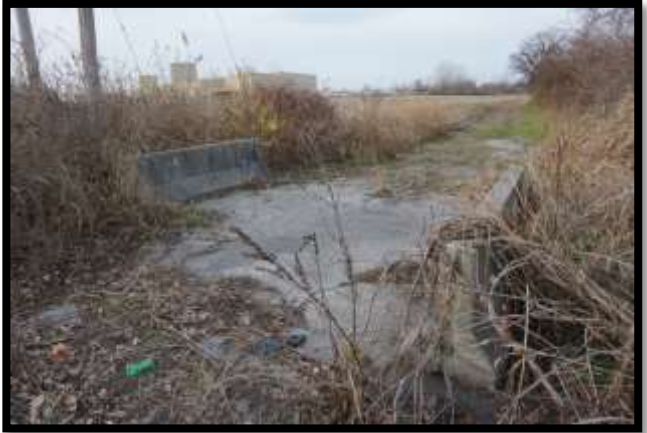
Photograph 10: Schaeffer Road property.

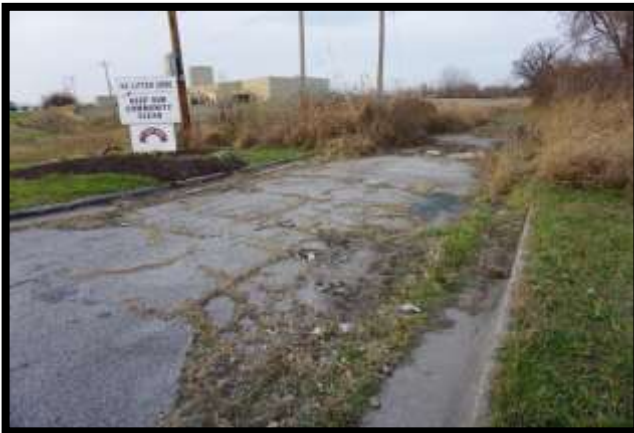
Photograph 11: Schaeffer Road property.

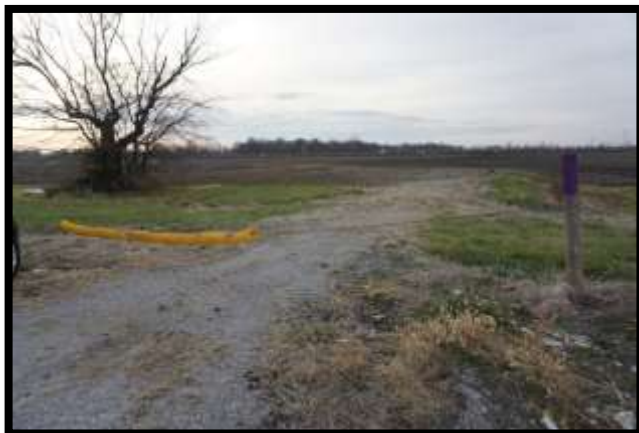
Photograph 1: Sand Road property (view from entrance).

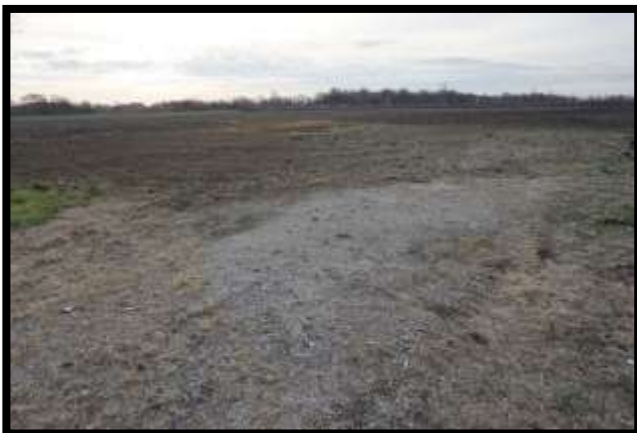
Photograph 2: Sand Road property (view from entrance).

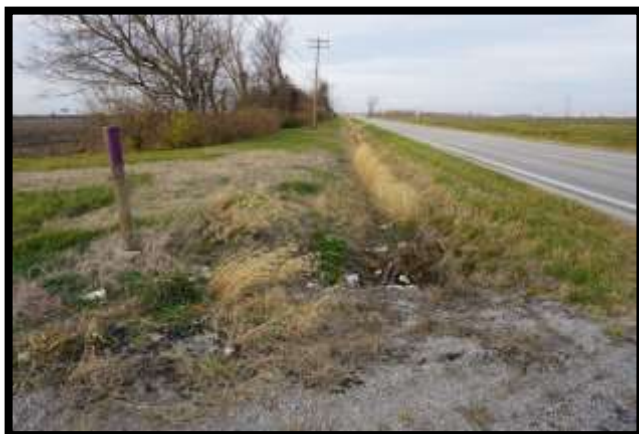
Photograph 9: Sand Road property, access road.

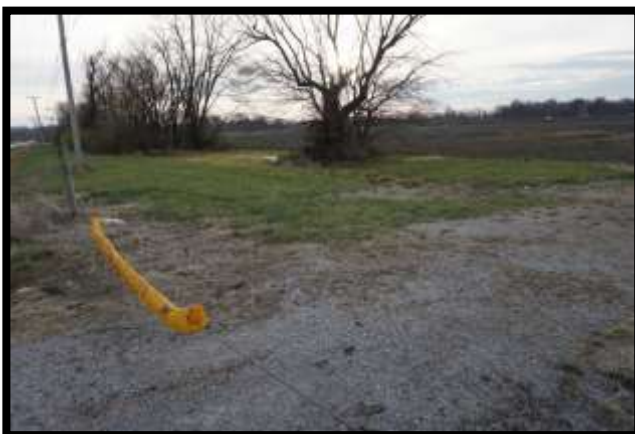
Photograph 10: Sand Road property, access road.
